## INSPECTION REPORT ON IMPORTANT MONUMENTS

Findings during the inspection

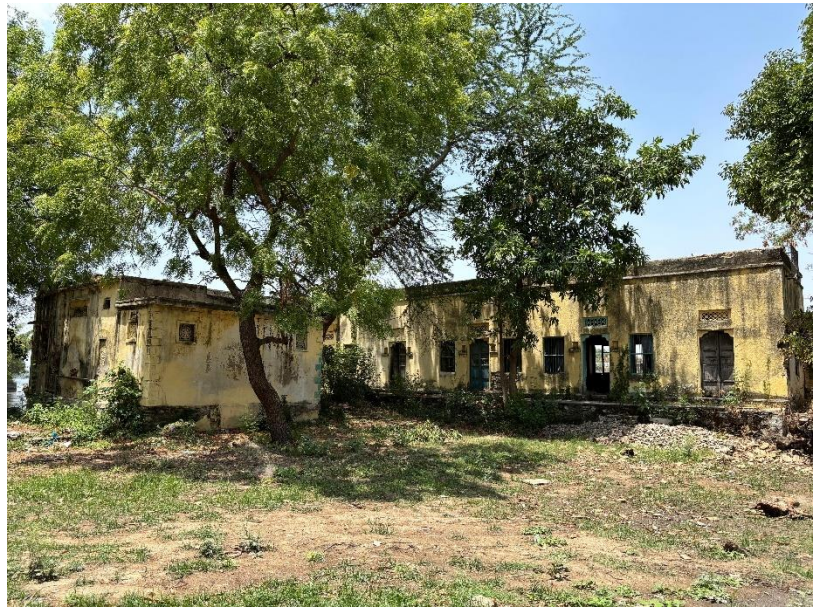
Front Entrance of Lake side monument.

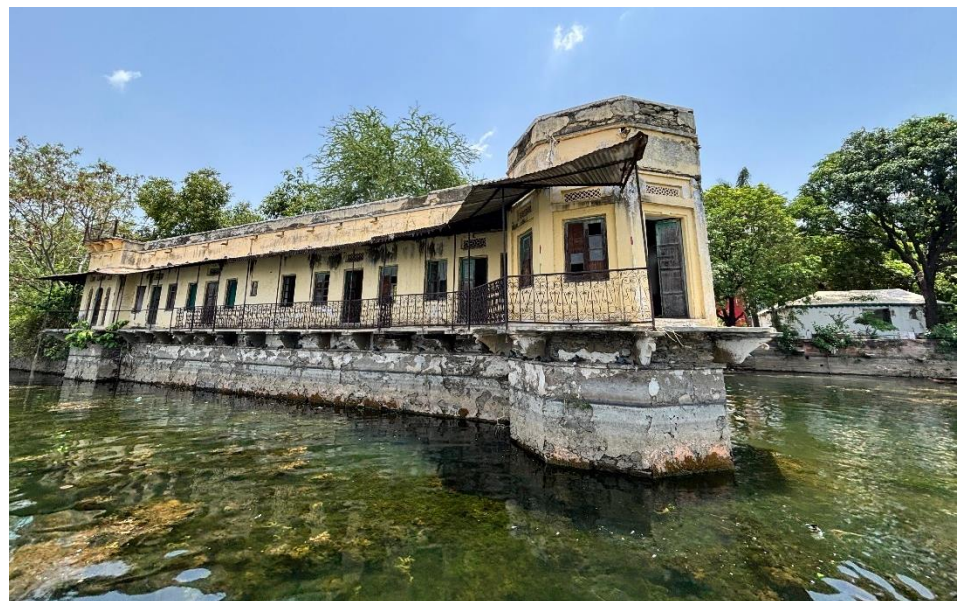
Condition  
assessment

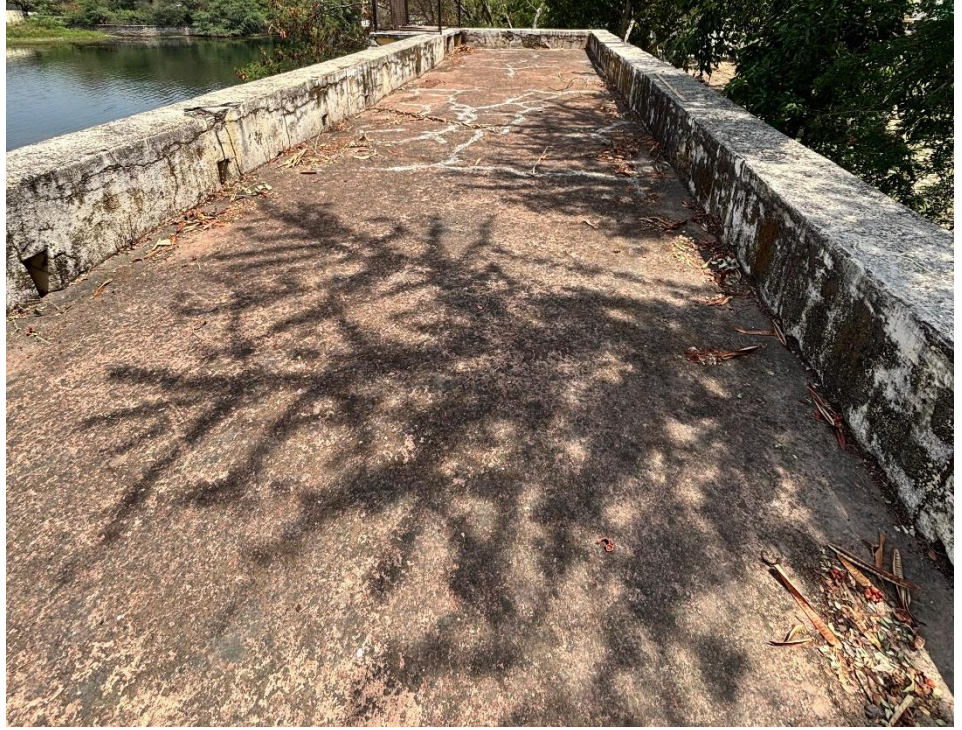
Roof top of the monuments in lime concreting

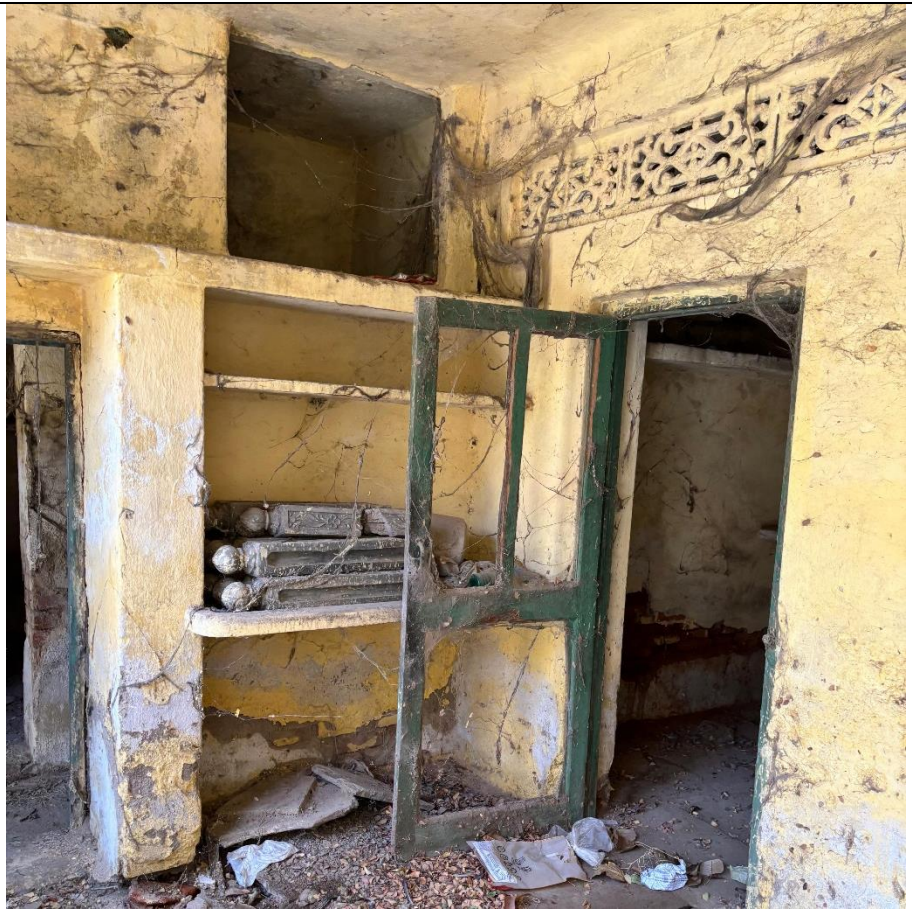
Damaged Doors and Windows

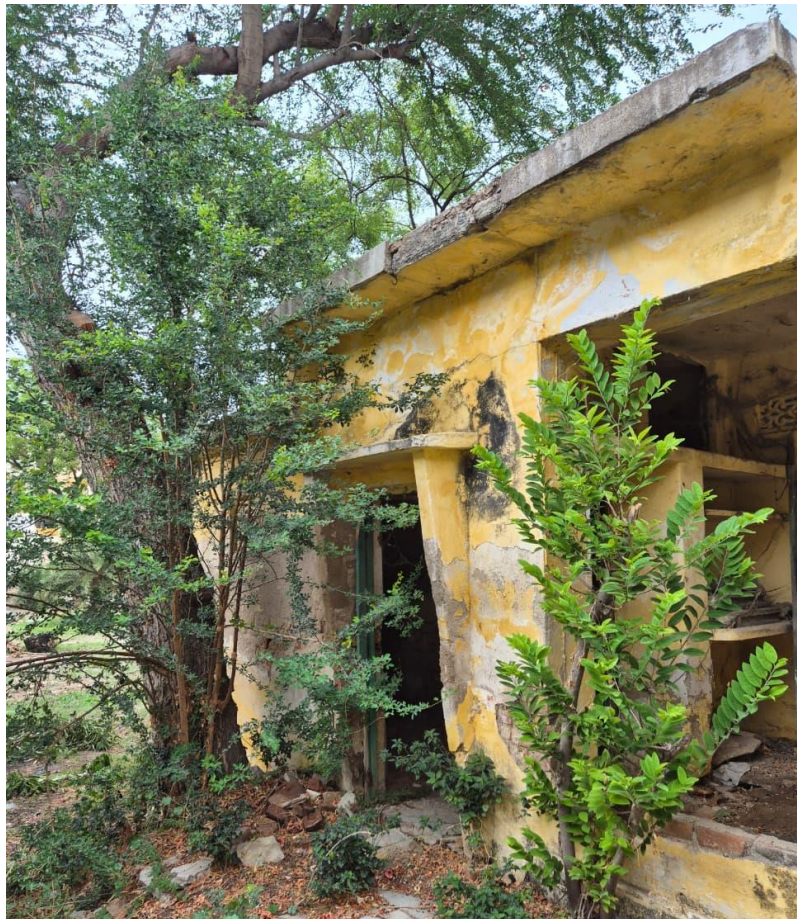
Tree causing damage to the walls

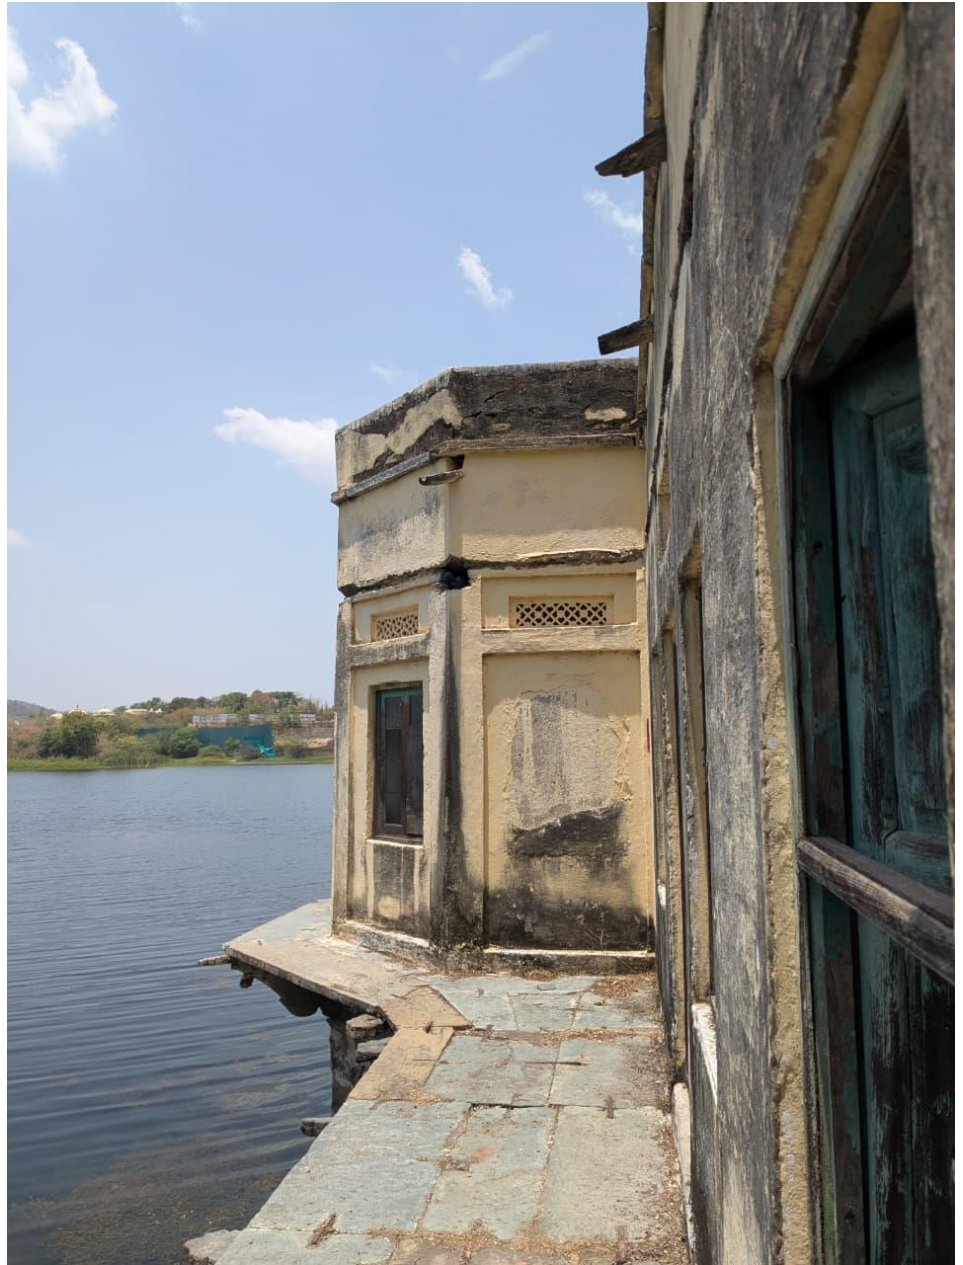
Lost MS railing and broken floor tile.

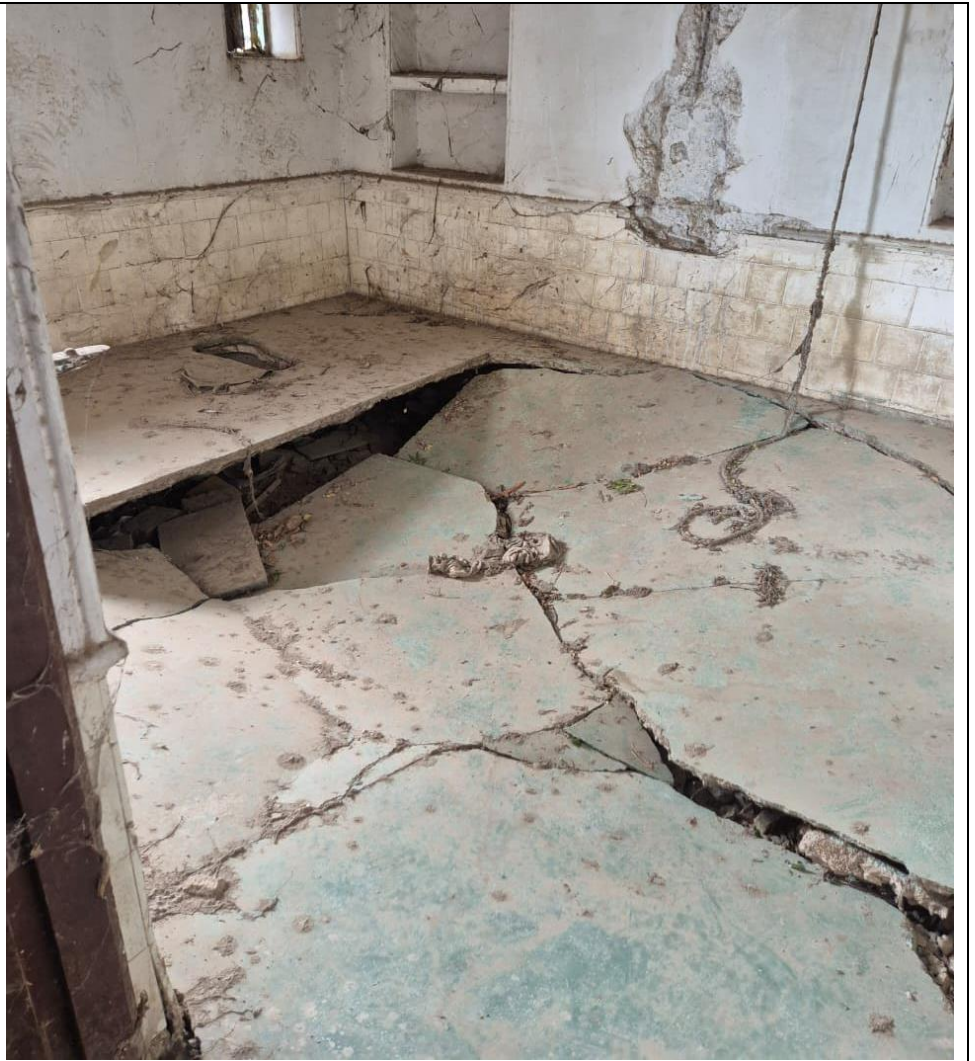
Floor caved in by more than 10 inches

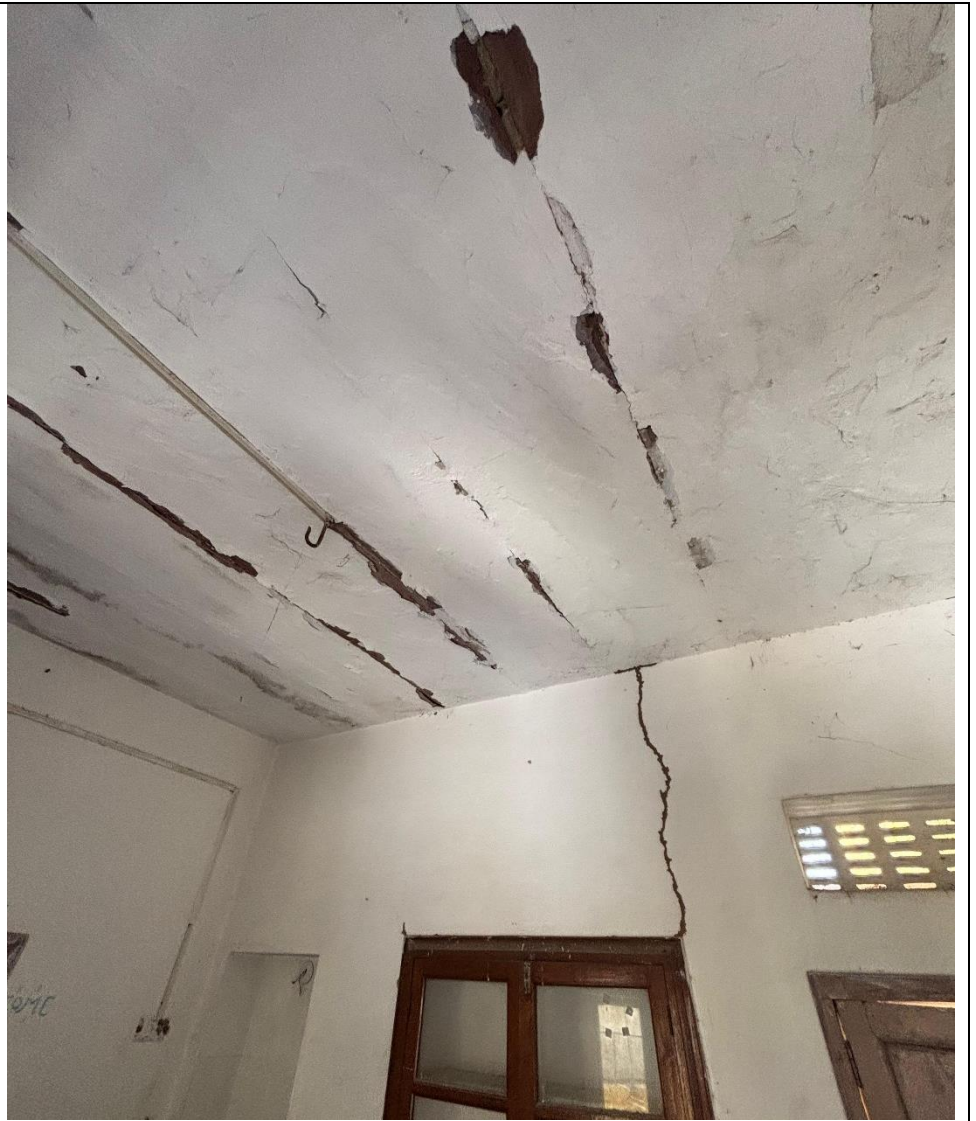
Termite and major roof cracks.

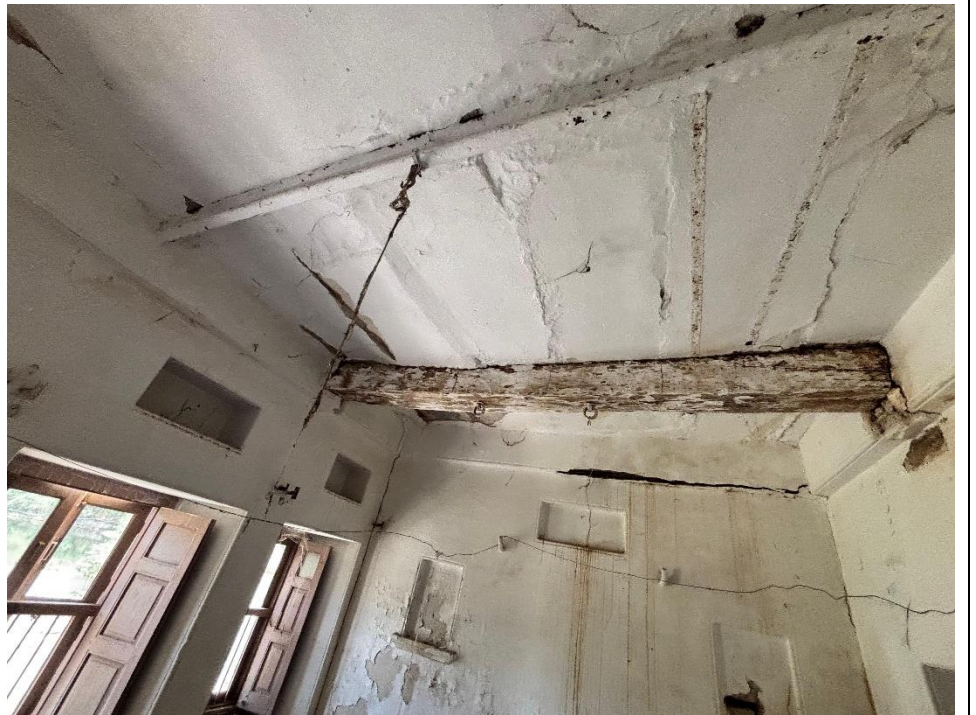
Wooden beam and sunken roof gone out of plum.

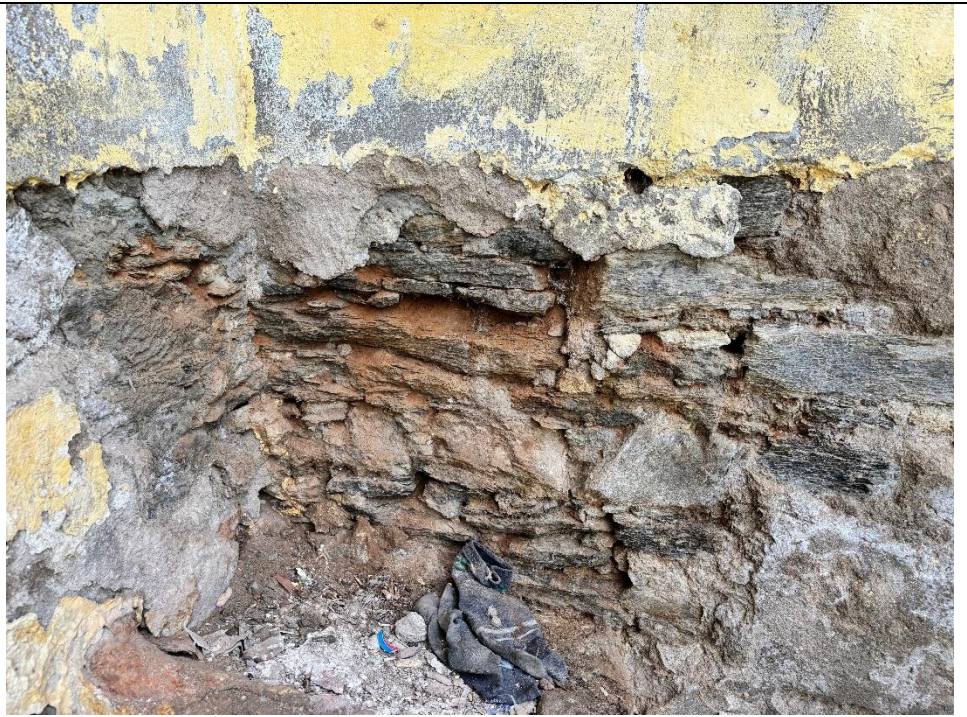
Lost / extensively damaged masonry

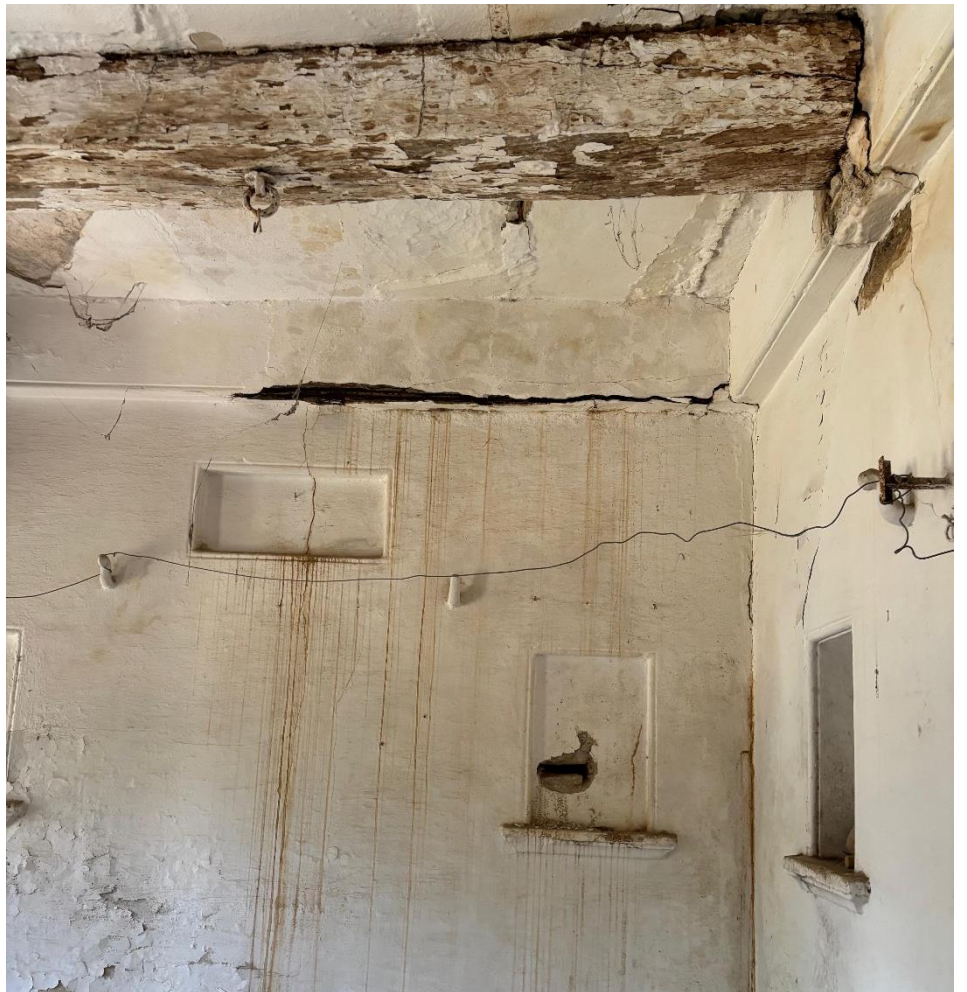
Large Cracks on beam causing water seepage

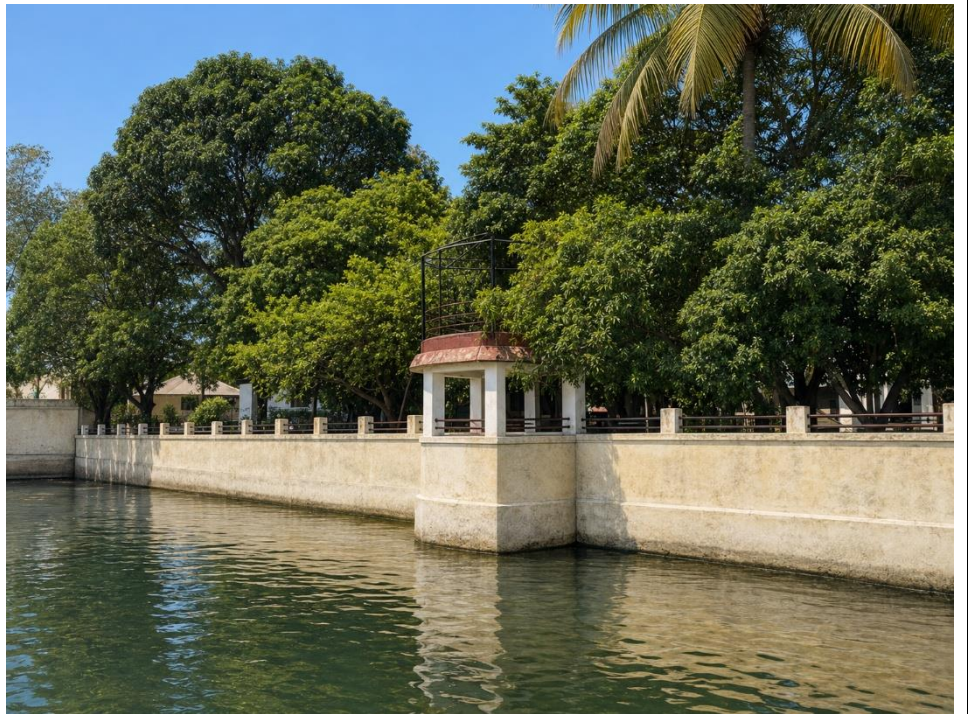
Post Conservation view
