## INSPECTION REPORT ON KHIRI BUDDHA MATH, GOLA

Period of inspection	May 19, 2026, (Sunday)		
Name of monument	Khairi Buddhist Monastery		Category of monument
			Individual
Address	Mathwa Tand in Gola block along the Ramgarh–Bokaro stretch of NH-23		
Location	State	District	Police Station
	Jharkhand	Khunti	Khunti
Latitude & Longitude	Lat. 23.597° N		Long. 85.804° E
Whether protected monument	No		
Authority of the bunglow	Individual		
Whether under religious use	No		
Accompanied by	Shri Chandan Kumar & Shri Ajay Kumar Mukherjee

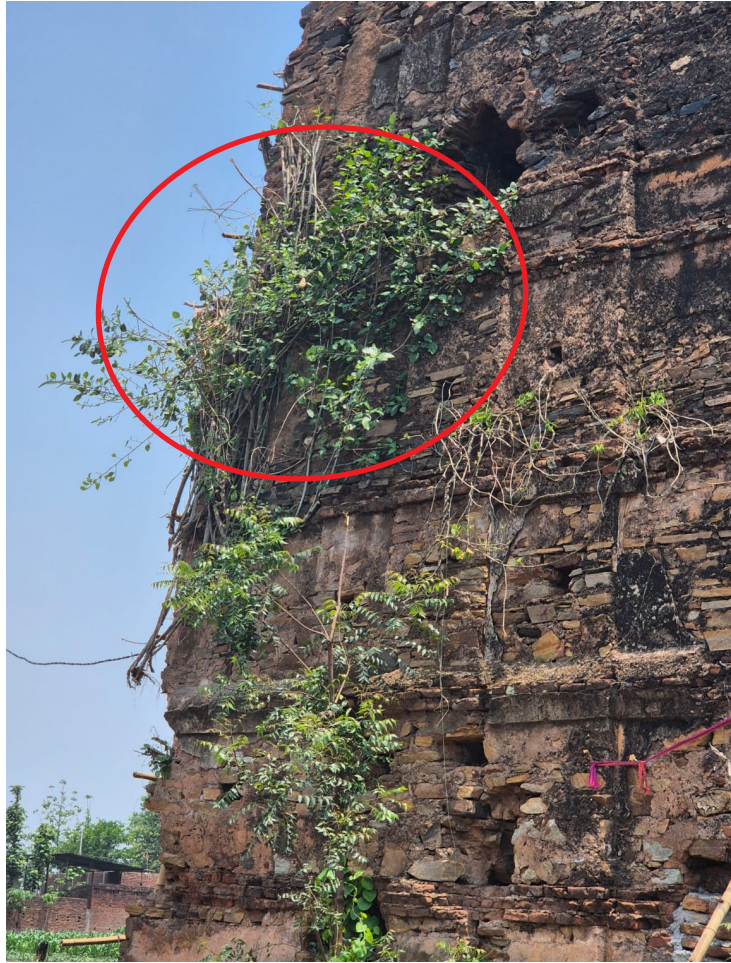
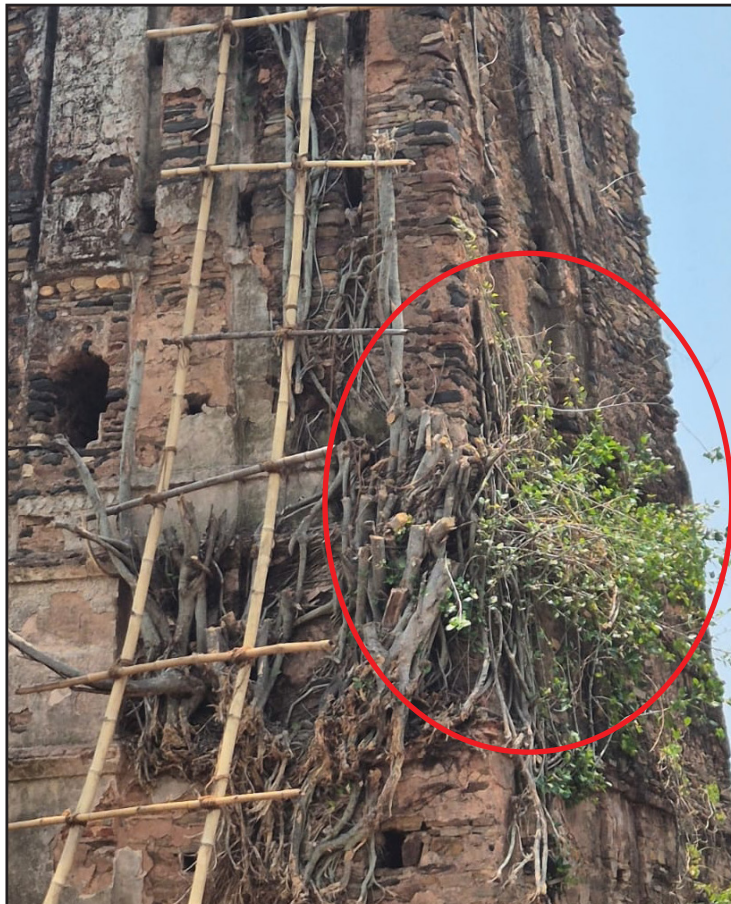
Vegetational growth

Desired Intervention	<ol style="list-style-type: none"> <li>1. The treatment of Rooftop is to be carried out in a big way. The top layer of the traditional casting is to be removed before casting a fresh layer.</li> <li>2. The areas where weeding has come up requires to be cleared in an appropriate manner and the roots within the building walls as well as on the roof is required to be taken up.</li> <li>3. The parapet walls are severally damaged at many cases and require thorough repair and water tight.</li> <li>4. There are vegetation / plants touching the outer walls of the building are causing a source for water seepage to the foundation of the building. It requires to be removed from there.</li> <li>5. The building requires to have nearly 3 feet of plinth protection all around to insure the rain water to remain away from the building.</li> <li>6. It is found that the plaster of the building both inside and outside has been repaired with cement plaster, which is against the conservation norms as originally surkhi - chuna plaster has been there.</li> <li>7. The floors of the building at many places have large cracks and at some places it has got depressed. Due intervention by a civil contractor is needed to set it right , if required.</li> <li>8. The building requires white washing both outside and within which can be saperataly taken up.</li> </ol>

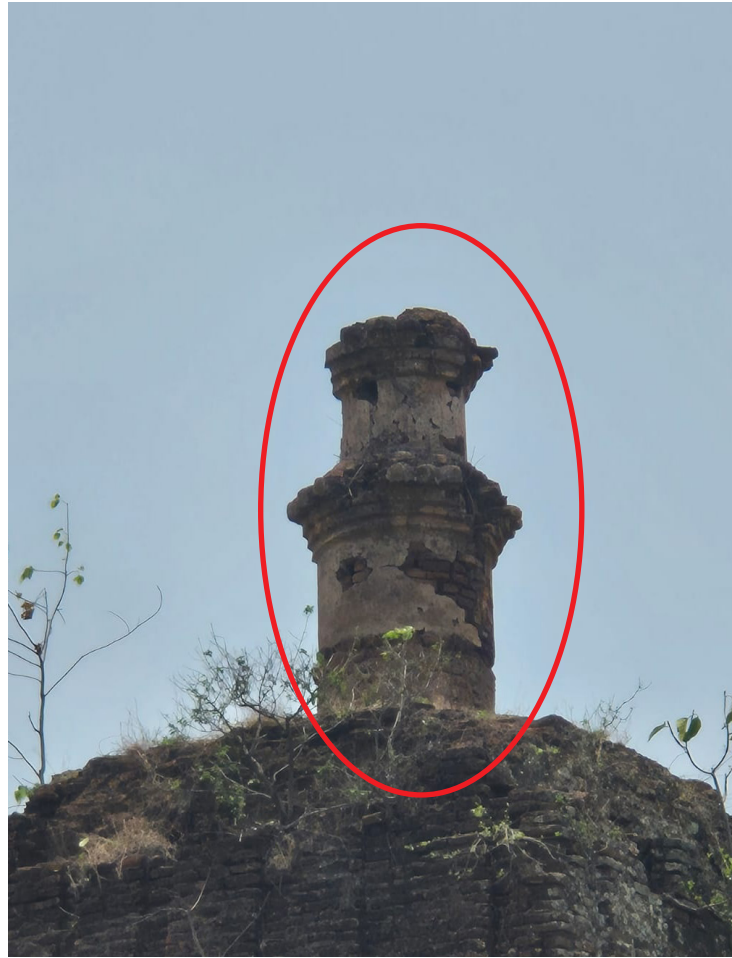
Broken Shikhara

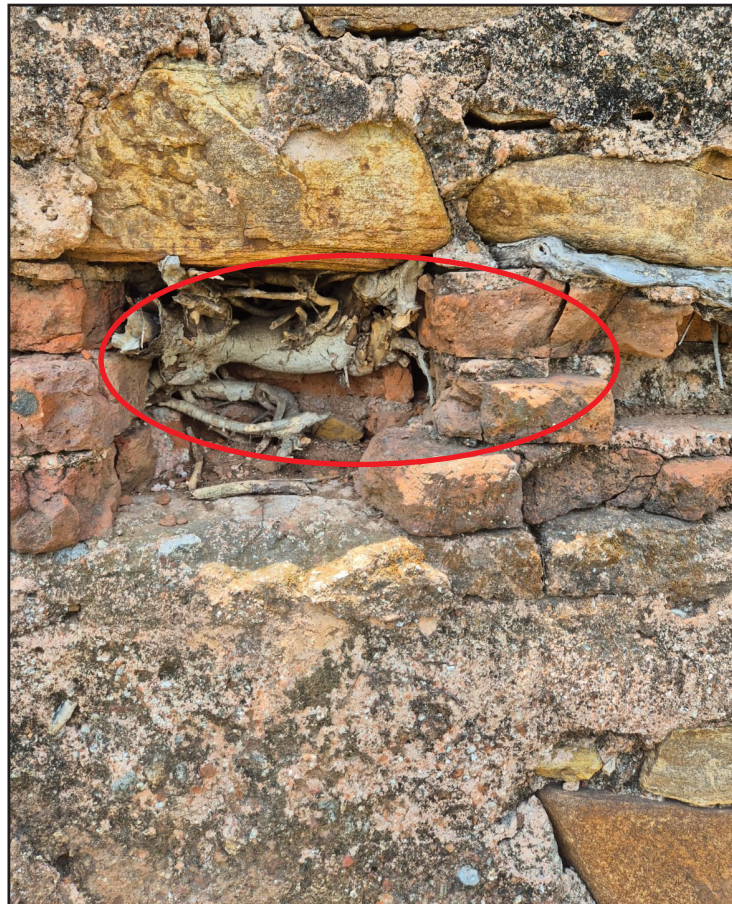
Root Invasion

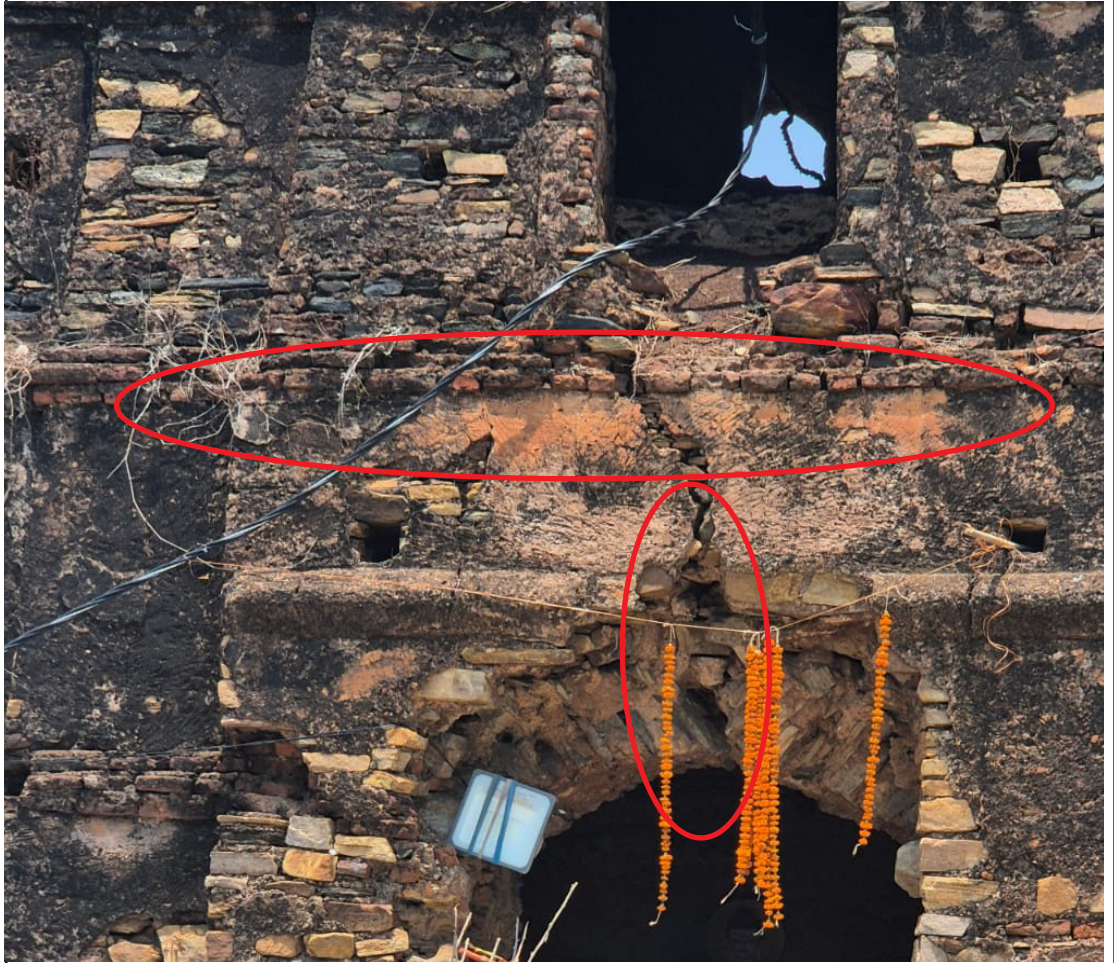
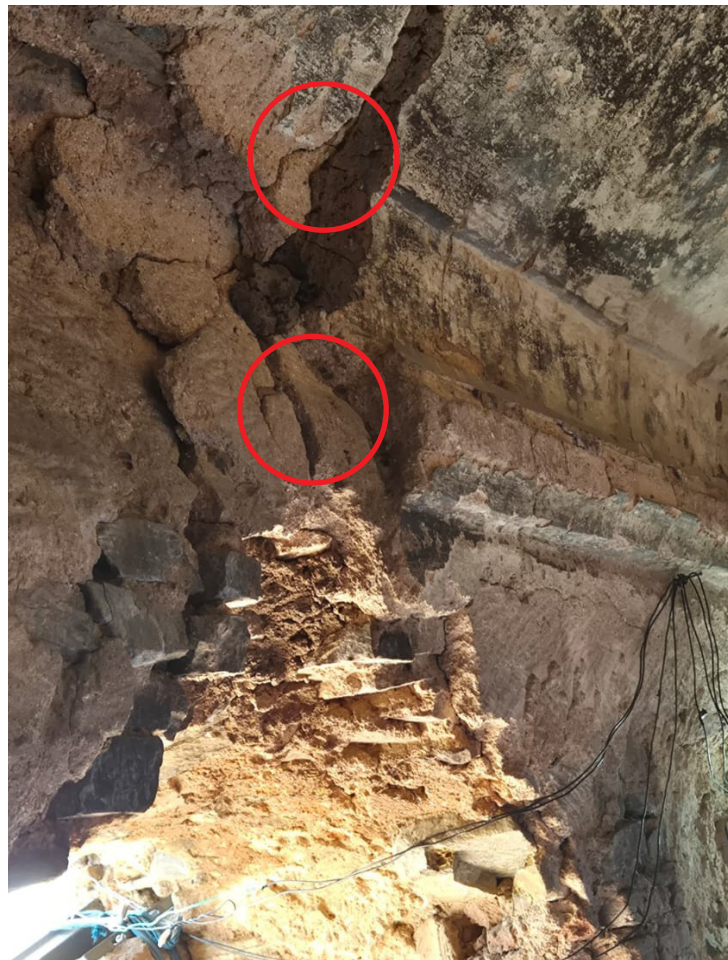
Large / Small Cracks

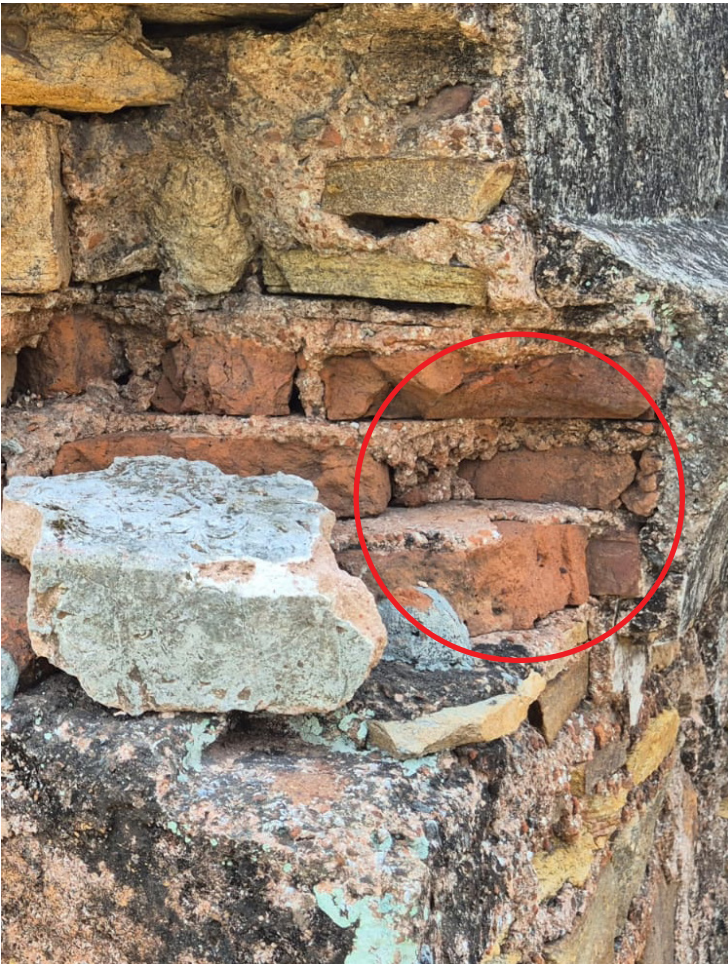
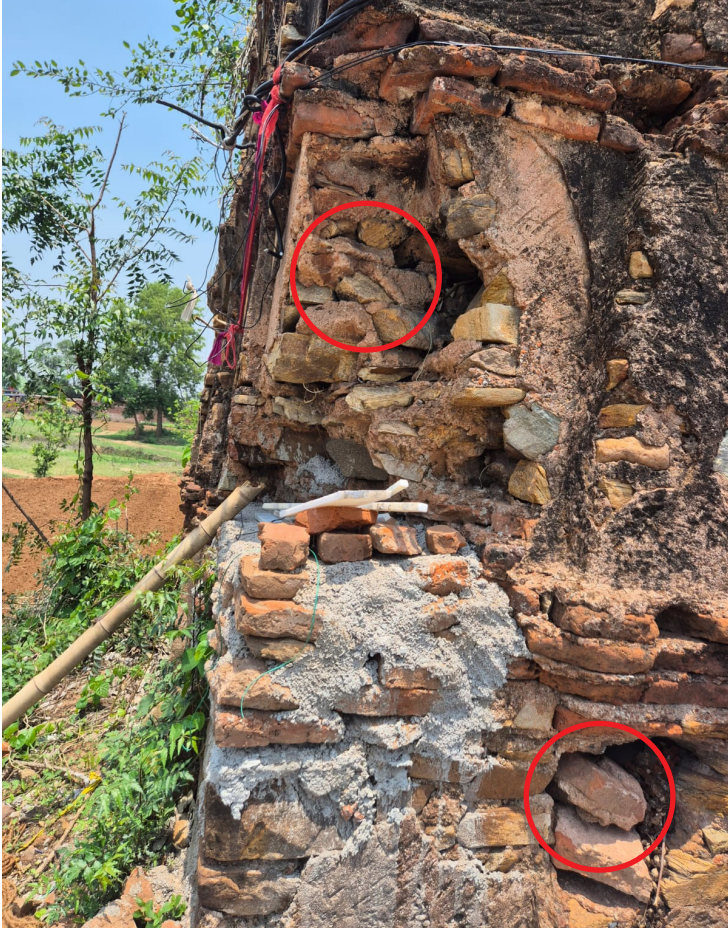
Fallen Bricks

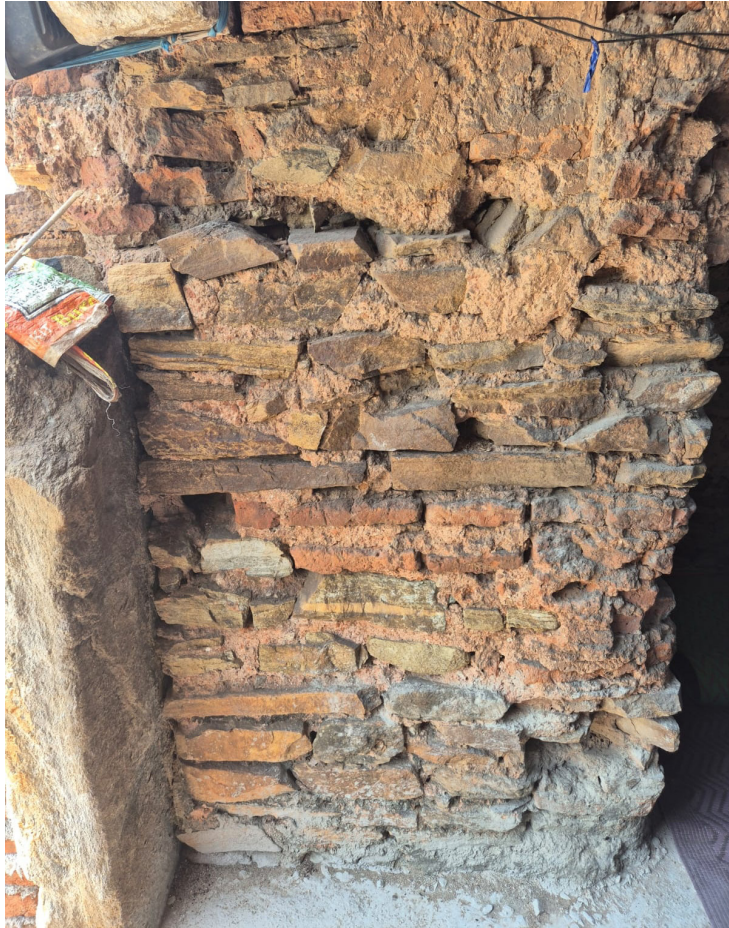
Fallen walls

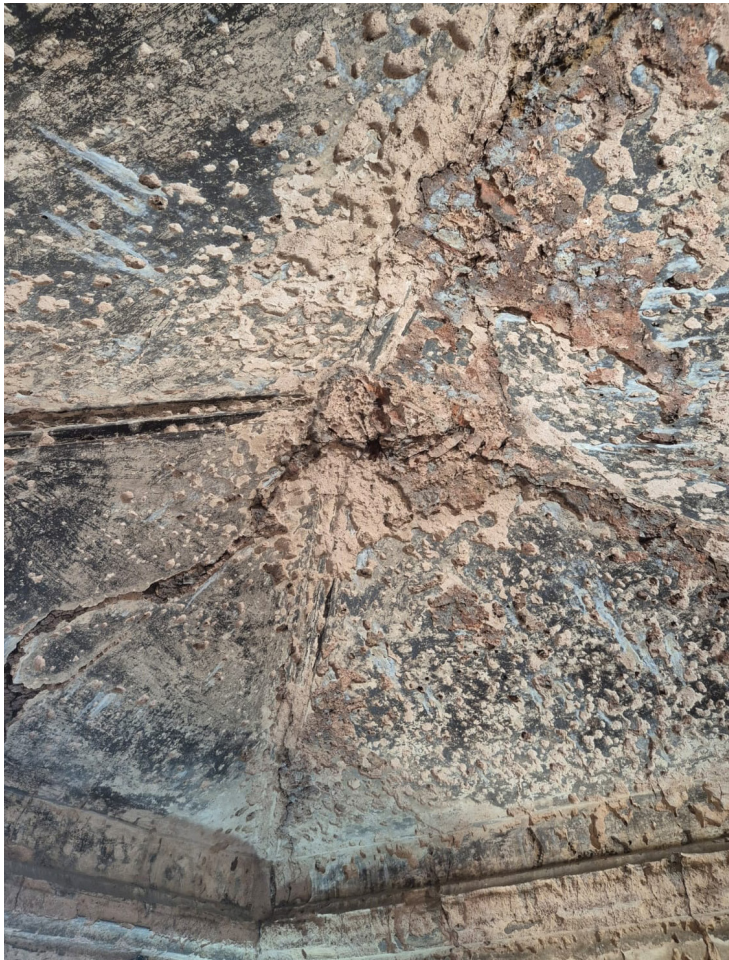
Fallen Roof
